FIELD EVALUATION OF AN UNGLAZED, BUILDING-INTEGRATED, SOLAR DOMESTIC WATER HEATING SYSTEM

Robb Aldrich
Douglas Owens
Steven Winter Associates, Inc.
50 Washington St.
Norwalk, CT 06854
raldrich@swinter.com
dowens@swinter.com

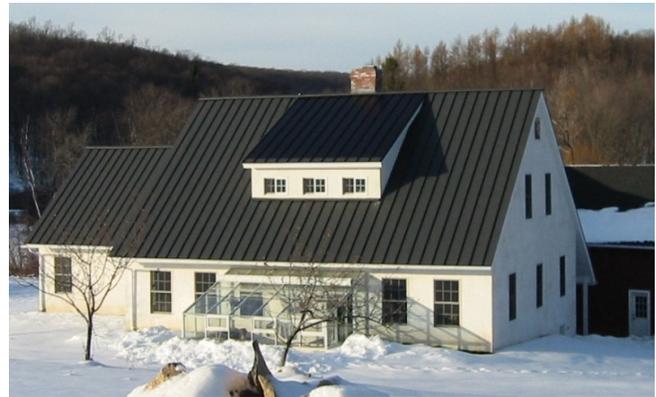
Fig. 1: The south side of the completed home with integrated solar systems.

The south-facing roof of the home (shown in Fig. 1) actually consists of three active solar systems. The main southern roof of the home (750 ft²) incorporates a solar thermal system for space heating. The southern shed dormer (250 ft²) supports both a thermal system (dedicated for domestic hot water) as well as a roof-integrated PV system using amorphous silicon laminates. Beneath the standing-seam metal roofs, the unglazed thermal collectors consist of cross-linked polyethylene (PEX) piping run in metal heat transfer plates. Propylene glycol solution is circulated through the collectors and through heat exchangers in storage tanks in the basement.

The solar systems in this home are designed to be very well integrated into the home's roof system (Fig. 1). From the outside, there is no visible evidence that solar thermal collectors exist on the south-facing roof, and the solar electric laminates (on the shed dormer) are very low-profile and difficult to detect.

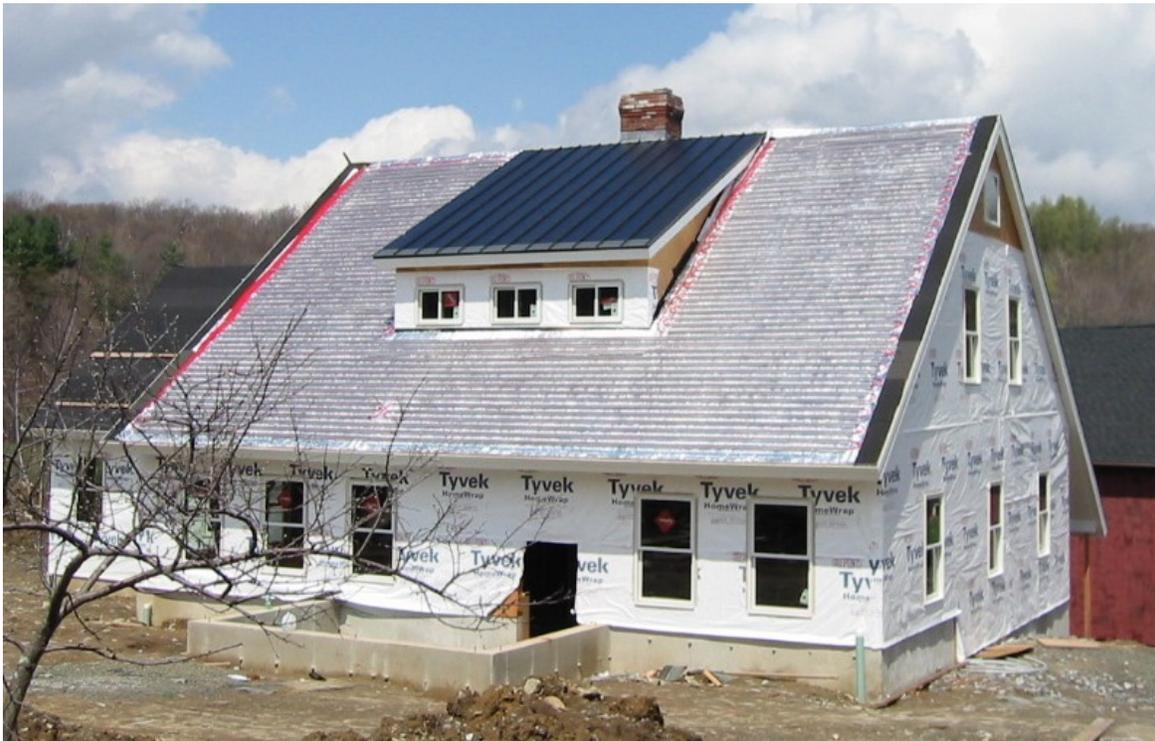
Fig. 2: The solar thermal collection system installed on main section of southern roof consists of red PEX tubing and metal heat transfer channels. On the shed dormer, the standing-seam metal roof and PV laminates have already been installed over the thermal collection components.

Above the roof deck and beneath the standing-seam metal roof, cross-linked polyethylene (PEX) tubing is plumbed through metal channels designed to hold the tubing in place while facilitating heat transfer (Fig. 2). The collector area for the small system discussed here is the 250-ft² area above the shed dormer on the southern roof. The PEX pipes above the roof deck connect to a manifold in the conditioned attic of the home, and larger PEX pipes run from the manifold to a heat exchanger located within a 120-gallon storage tank in the basement. A differential controller senses the temperature beneath the metal roofing as well as in the

As discussed above, the larger surface of the southern roof also incorporates solar thermal collection. This collector area is part of a separate system intended for space heating. The shed dormer (shown in Fig. 2 with metal roofing already installed) also includes amorphous silicon PV laminates. Because these two solar systems had not been commissioned when the monitoring began, analysis of their performance is not included in this paper.

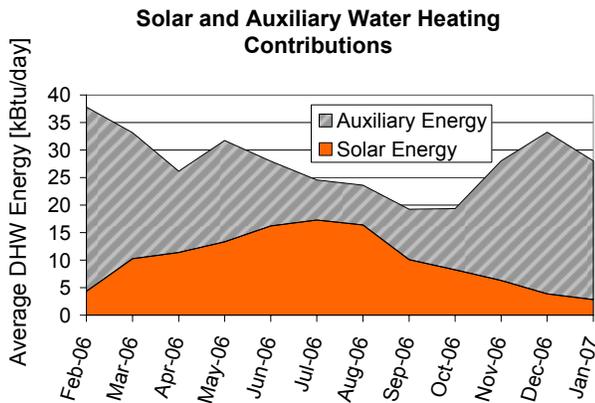
Fig. 3: Average daily energy required to heat hot water during each month monitored. Shaded areas show portions provided by solar and auxiliary propane water heater.

As expected with an unglazed thermal system, performance varied greatly with outdoor temperatures. In January, for example, the system provided only 10% of the water heating load. In July, by contrast, the solar fraction was 60%. The monthly contributions of solar (along with auxiliary energy required) are shown in Fig. 3.

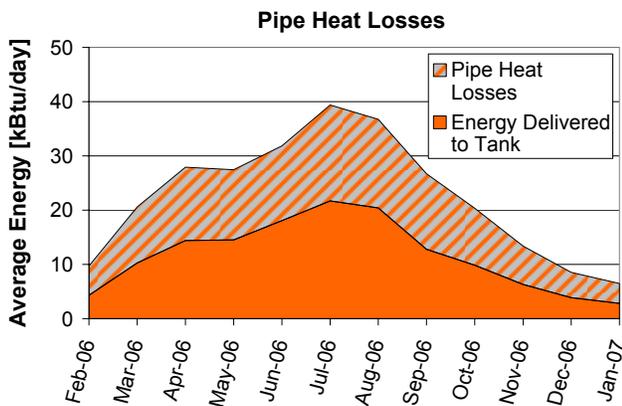
Fig. 4: Average daily heat collected from the roof each month. Areas show both the heat delivered to the storage tank and heat lost from piping.

Over the 12-month monitoring period, 8.2 MMBtu were collected from the 250-ft² collector on the dormer roof (measured using the temperature differentials at the attic manifolds). Only 4.3 MMBtu, or 52%, were transferred to the solar tank heat exchanger. The balance was lost through convection and conduction from fluid in the piping.

When heated glycol reached temperatures of 100°F or more (as measured in the attic manifold), the fluid was between 5°F and 10°F cooler when it reached the solar tank in the basement. In a low-temperature system, this results in a significant overall energy loss.
