Kotzebue Electric Association  
Solar Thermal Alternative Residential Heating Methods

Quarterly Report

3/31/2011

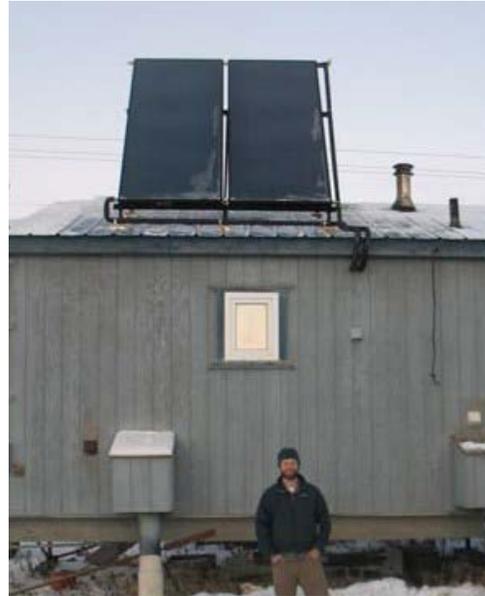
Heliodyne Flat Plate Solar Collector.  
*Jesse Logan (KEA).*

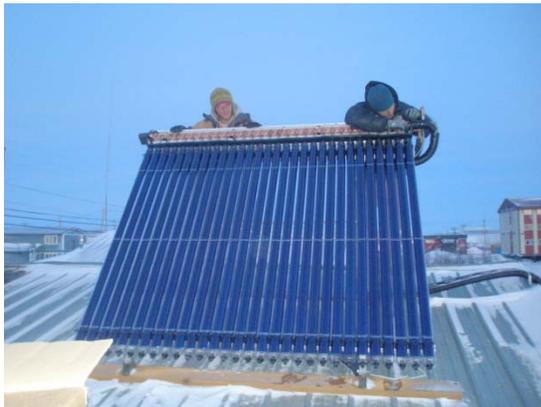
Viessmann 1: David Lindeen (SES) and Jesse Logan (KEA)

Vitosol 300-TSP3 (30) Evacuated Tubes.

Solar Collector Vitosol 300-TSP3 (30) Evacuated Tube (@ 68 degrees)  
Solar energy storage Vitocell-V 100CVA- Single Coil Tank (80 gal)  
Pump Solar Divicon DN-20 w/ Star 16U-15 Circ Pump  
Control Viessmann Solar Control Unit SCU 124 (7416043)  
Data logging Resol Data logger DL2  
Solar fluid line set Insulated Corrugated stainless steel piping

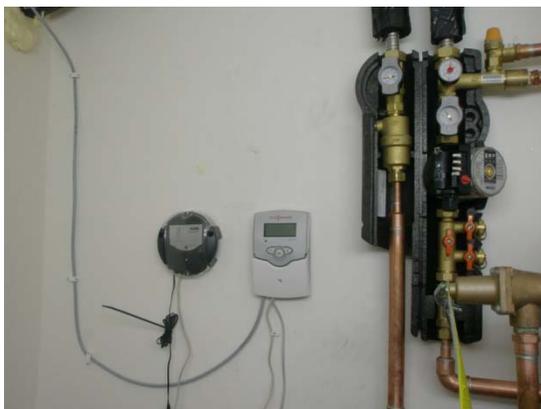
Viessmann 1: Utility Room

Preliminary wiring From Left to Right:  
Resol Data logger DL2  
SCU 124 (7416043) Control Unit  
Solar Divicon DN-20 w/ Star 16U-15 Circ Pump

As with all the Viessmann systems the controls and data logger are separate units and communicate via a VBus connection. Data is stored in the DL2 and retrieved via SD card slot or connected to a computer via Ethernet LAN. SES was not familiar with the DL2 and could offer very little assistance in the set up, logging or data retrieval methods. Resol software is required to communicate with the DL2 directly or alternatively, to format retrieved data via SD card.

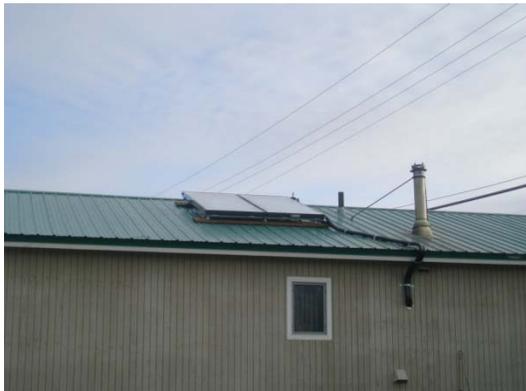
Viessmann 2: Flat Plate Collector

(2) Vitosol 200-F Vertical Flat Plate Collector  
(@29degrees)

Solar Collector	(2) Vitosol 200-F Vertical Flat Plate Collector (@29degrees)
Solar energy storage	Vitocell-B CVB Dual Coil Storage Tank (80gal)
Pump	Solar Divicon DN-20 w/ Star 16U-15 Circ Pump
Control	Viessmann Solar Control Unit SCU 124 (7416043)
Data logging	Resol Data logger DL2
Solar fluid line set	Insulated Corrugated stainless steel piping

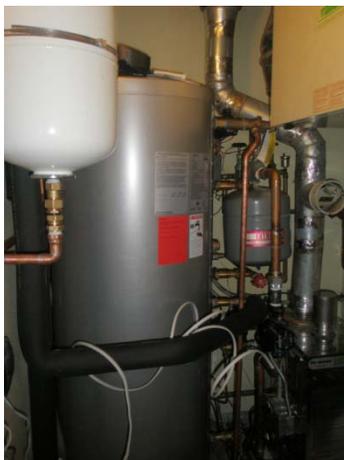
Vitocell-B CVB Dual Coil Storage Tank(80gal)

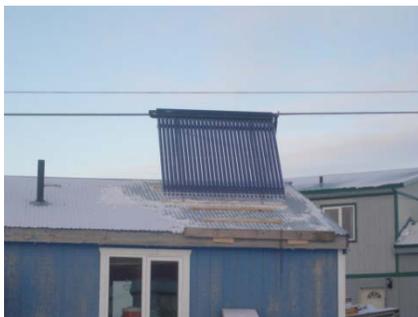
King Span solar evacuated tube (30) (@ 68degrees)

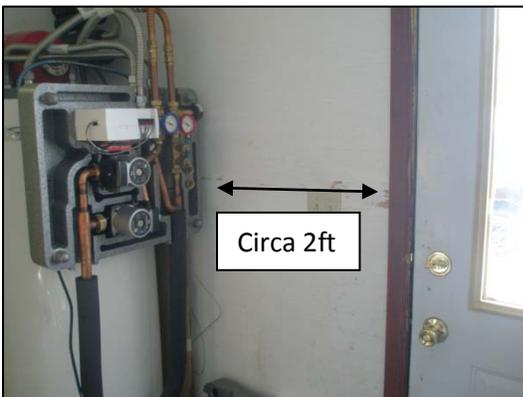
Pro-lite controller and Hilio-pack pro heat exchanger with Wi-Fi and data logging. (uncovered)

The Heliodyne system controls and data loggers are a single unit. The controls settings and data logger features are accessible via WiFi communication (the unit itself sends a short range WiFi signal that a WiFi enabled laptop can connect to). Each system has a unique IP address to log enable communications. This makes interfacing with the controls and downloading data very simple.

On System 4 the Helio-pack was mounted to the storage tank as usual. This was in a heated entry way. However, during a severe winter storm in January 2011 high winds penetrated the front door of the home. The circa 2ft proximity of the Helio-pack was insufficient to protect the lower of the two pumps (DHW) shown in the pictures. This pump froze. Appropriate measures had been taken when plumbing this system and KEA was able to isolate this circulation line with no disruption to DHW for the house. However, this rendered the solar thermal system inoperable awaiting the installation of a new pump.

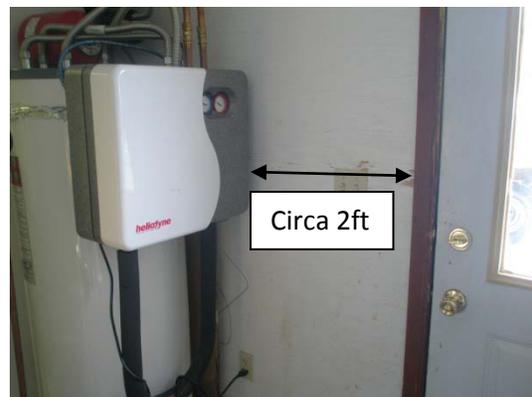
Pro-lite controller and Hilio-pack pro heat exchanger with Wi-Fi and data logging. (insulated cover)

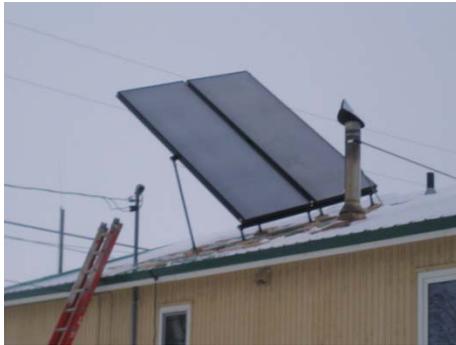
Gobi 410 flat plate (2). Mounting brackets rated to withstand 100mph winds.

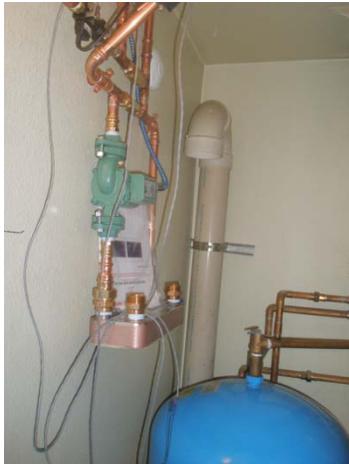
Auxiliary pump and flat plate heat exchanger for hydronic base board heating loop.

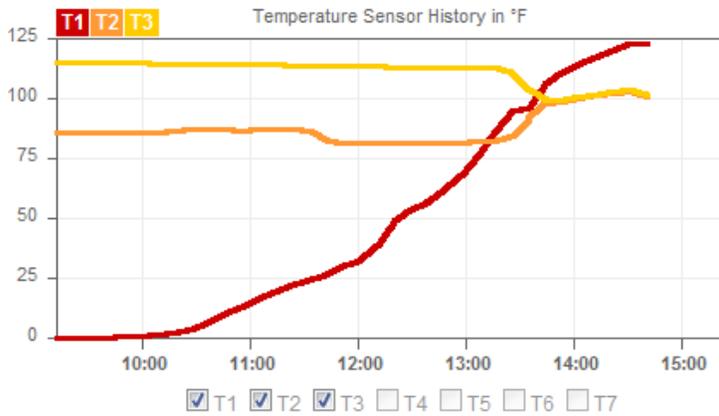
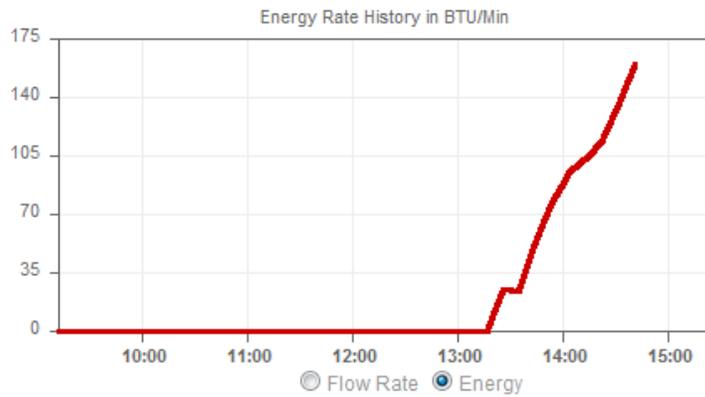
System 6  
 Heliodyne Gobi Flat Plate Collector  
 Combined DHW and Hydronic Base Board Heating  
 Preliminary Data (2/28-3/28)

SYSTEM
ENERGY
SETTINGS

**Solar System Status**

Solar differential operation is active

Current Solar Differential	<b>23.2°F</b>
T1: Collector Out	<b>122.3°F</b>
T2: Storage Low	<b>99.1°F</b>
T3: Storage High	<b>99.6°F</b>
T4: Water HX In	<b>122.5°F</b>
T5: Water HX Out	<b>104.9°F</b>
T6: Glycol HX Out	<b>114.8°F</b>

VFS Sensor **2.9GPM**

Relay One: Solar **Active**  
 Relay Two Off

Due to these issues with Systems 4 and 5, KEA has no production data to report for the spring of 2011. However, the following are production values for system 6.

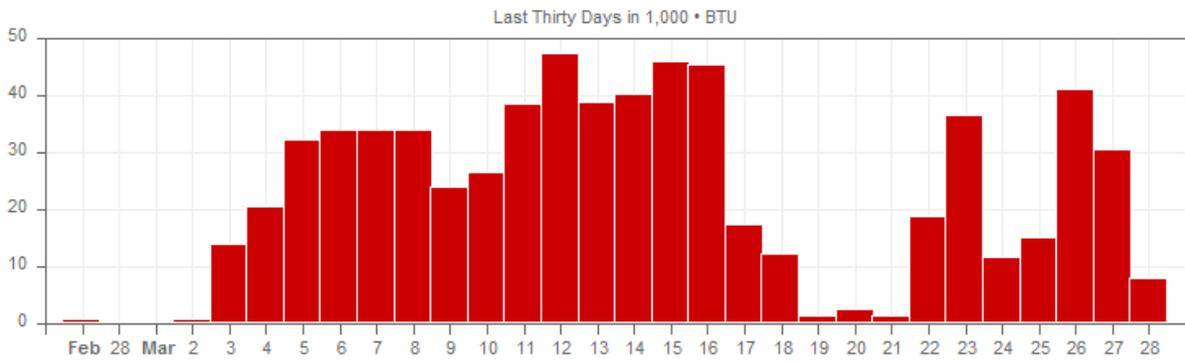
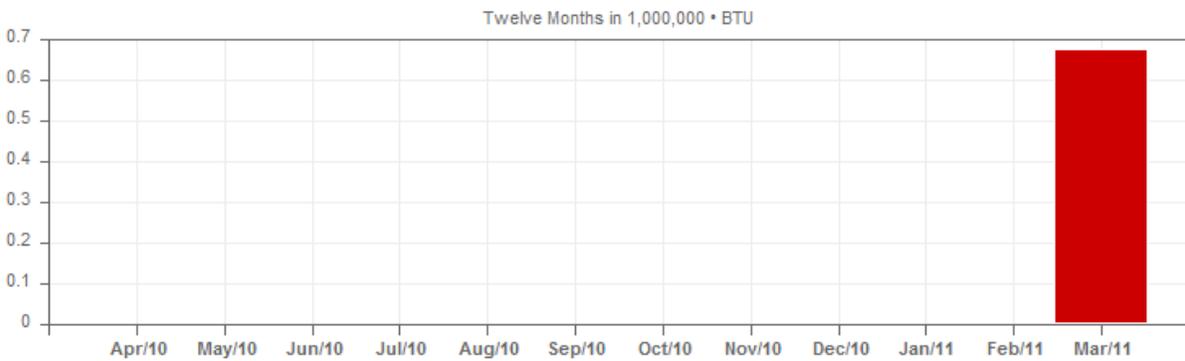
Monday 14:42 | March 28, 2011
